Product Type Topload Washer
Purpose Service Procedure
Interchangeable Yes
Subject Balance Ring Contacting Tub Cover in Spin Cycle

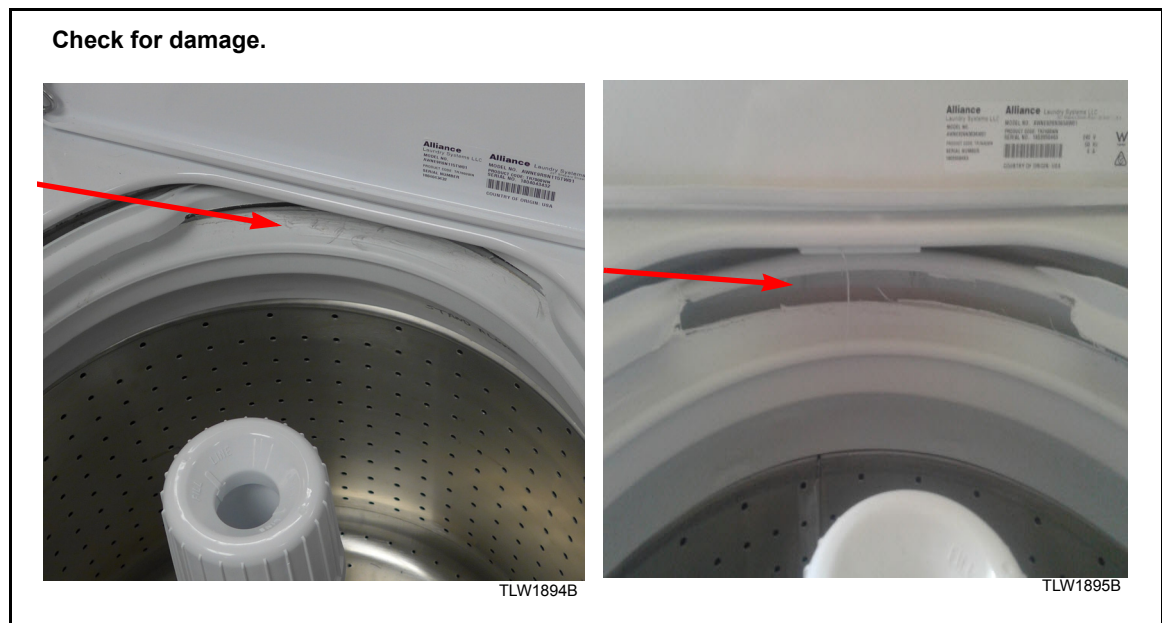
Figure 1

All three parts should be replaced if there is damage to both the balance ring and the upper tub cover. Refer to *Figures 1* and *2*. If the damage is isolated to the tub cover only, and **not** the balance ring, it is most likely due to the consumer overloading the unit resulting in fabric being stuck between the balance ring and the upper tub cover. In this case, replace the tub cover only.

1. Balance ring (Part No. 39837)
2. Wash tub (Part No. 719P3)
3. Tub cover (Dependent on model type. Refer to Parts Connection.)

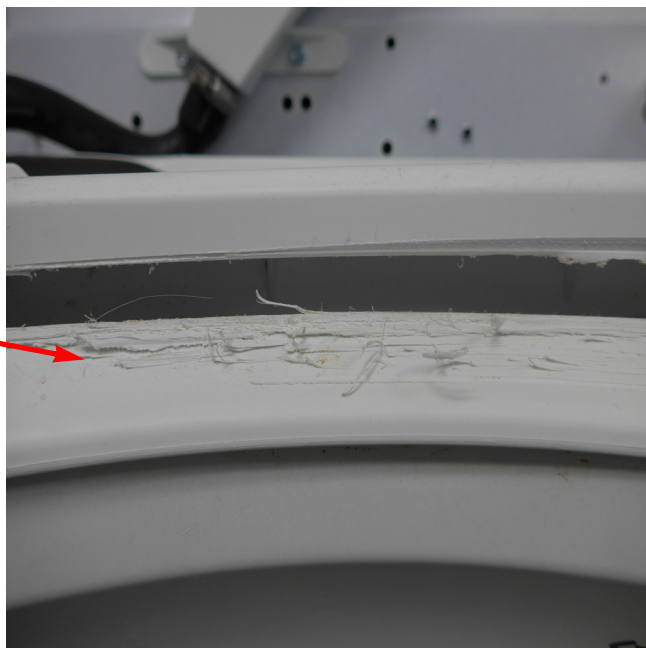
Figure 2

Check for damage.

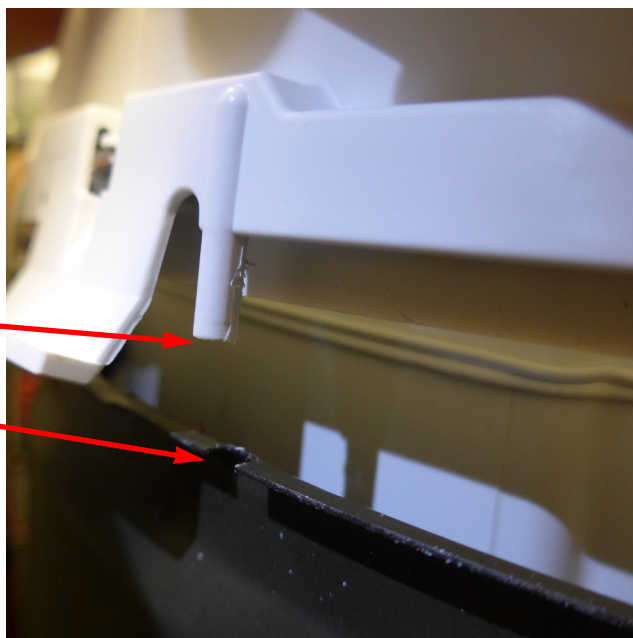
Figure 3

Properly align locator pin with notch.

NOTE: When reinstalling the upper tub cover, the locator pin and notch in the outer tub must be properly aligned. Refer to *Figure 3*.
